Project Name: Baker Street Redevelopment  
Project Number: CE751900

**Subject: Compilation of Documents for Modified Generic Risk Assessment No. 7882-BRYP6L  
55 Baker St., 152 & 160 Wyndham St. N. and Park Lane, Guelph**

1. *Pre-submission Form and Modified Generic Risk Assessment for 55 Baker Street, 152 and 160 Wyndham Street North, and Park Lane, Guelph, ON. Revision 1, dated October 20, 2020.*

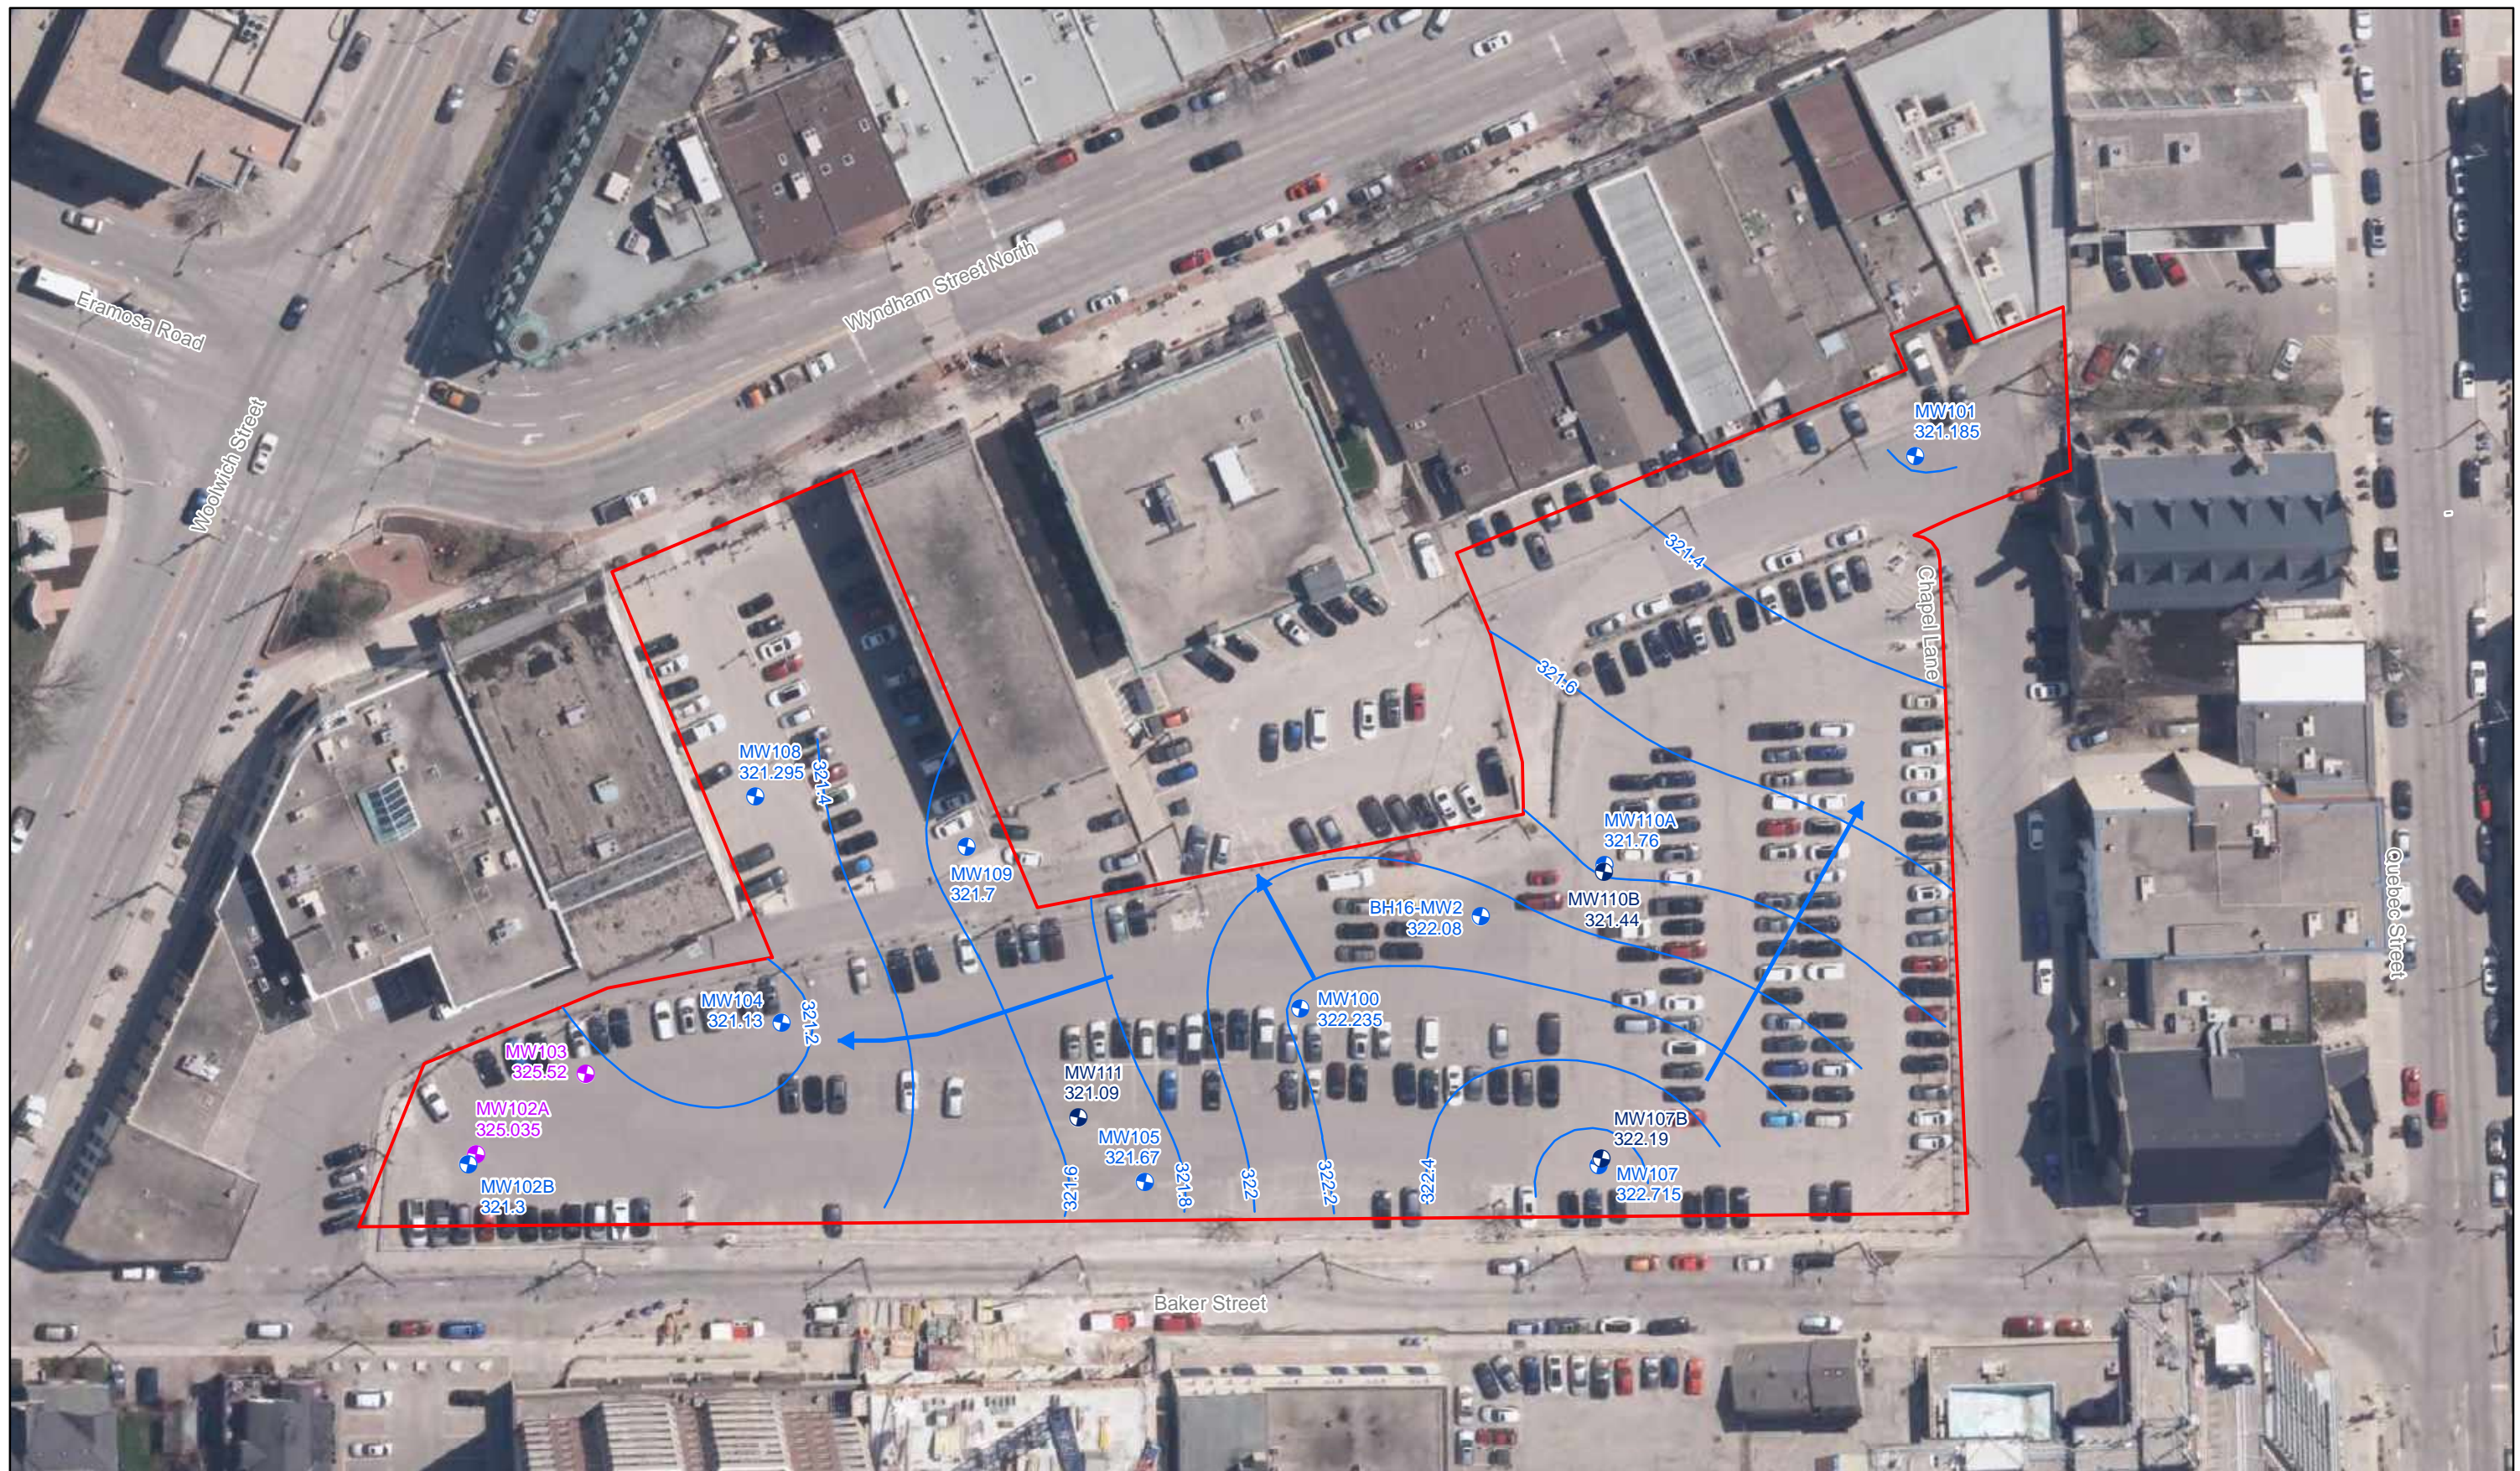
Figure 6-2b  
 Groundwater Contours - December 2019  
 Phase Two Environmental Site Assessment  
 55 Baker Street, 152 and 160 Wyndham Street  
 North and Park Lane, Guelph, Ontario  
 Date Exported: 6/9/2020

December 18, 2019 Groundwater Elevations (mASL)

[Appendix C](#), Figures 6-2a, 6-2b, and 6-2c present the interpreted groundwater elevation contours and flow directions within the bedrock (water table) using groundwater elevations collected during the monitoring events on September 11 and 18, 2019; December 18, 2019; and April 15, 2020, respectively.

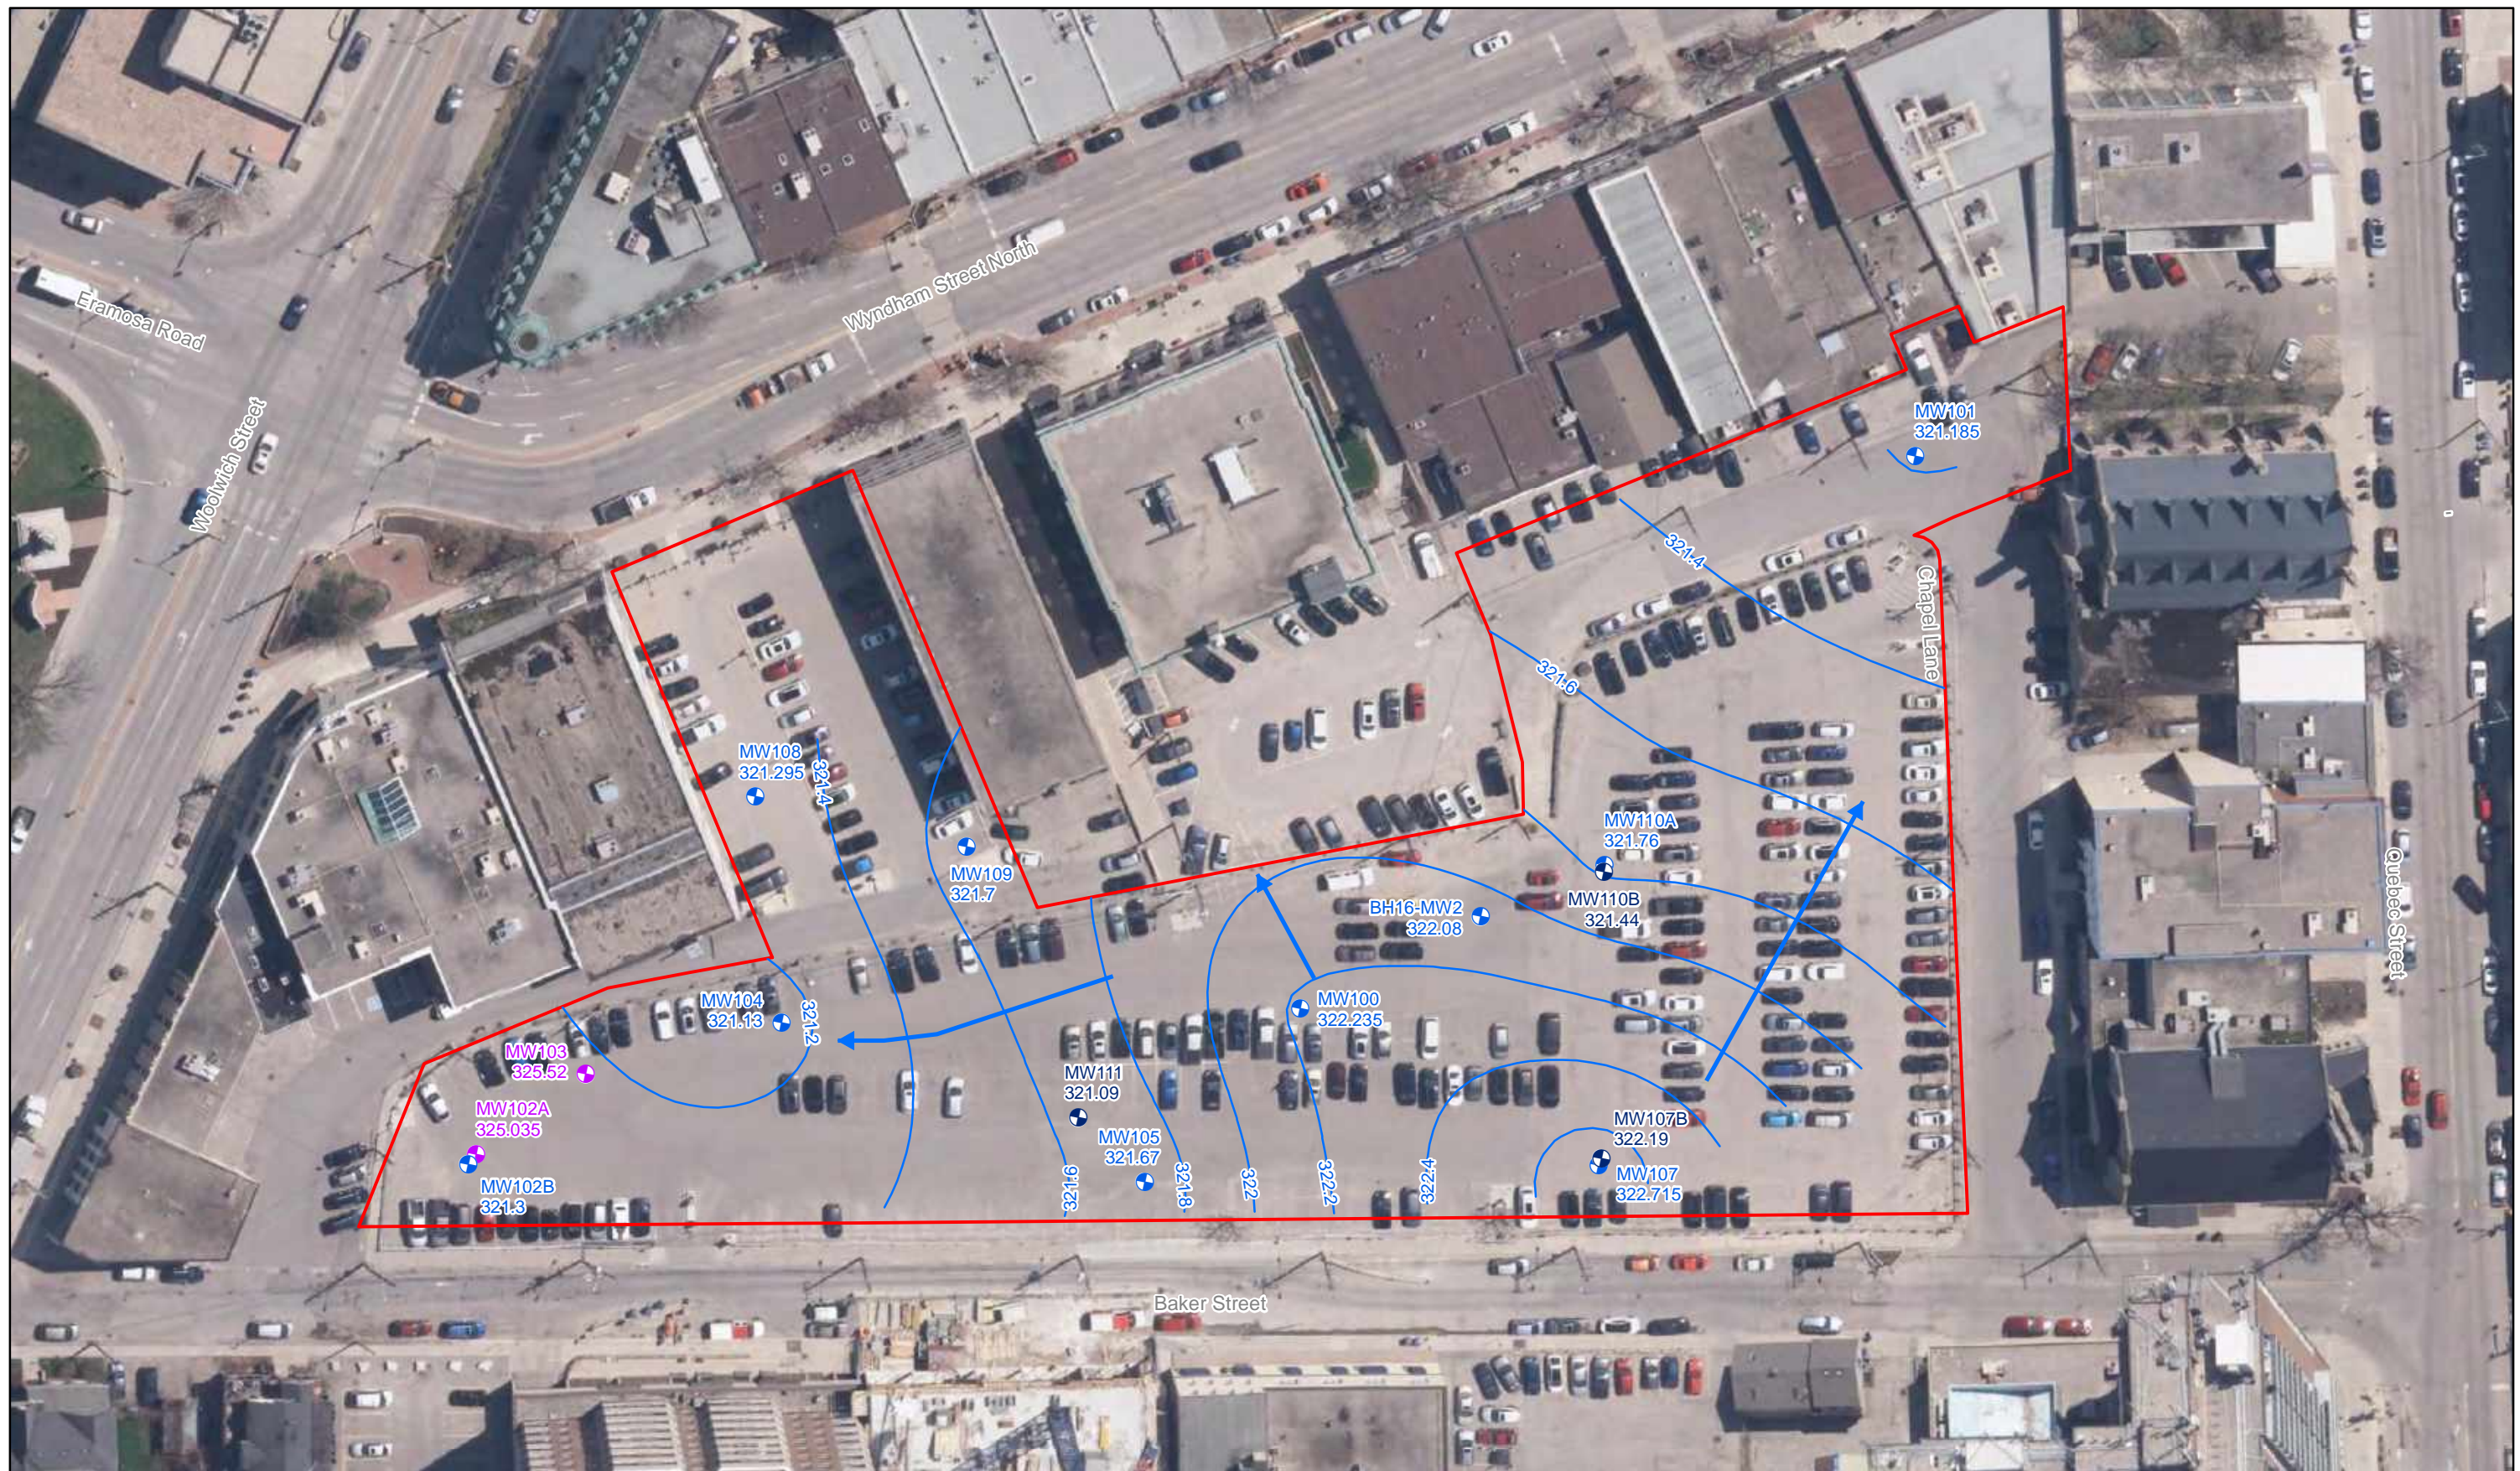
**Figure H-3a**  
 Groundwater Contours - September 2019  
 MGRA Supporting Information  
 55 Baker Street, 152 and 160 Wynndham Street North and Park Lane, Guelph, Ontario  
 Date Exported: 6/9/2020

December 18, 2019 Groundwater Elevations (mASL)

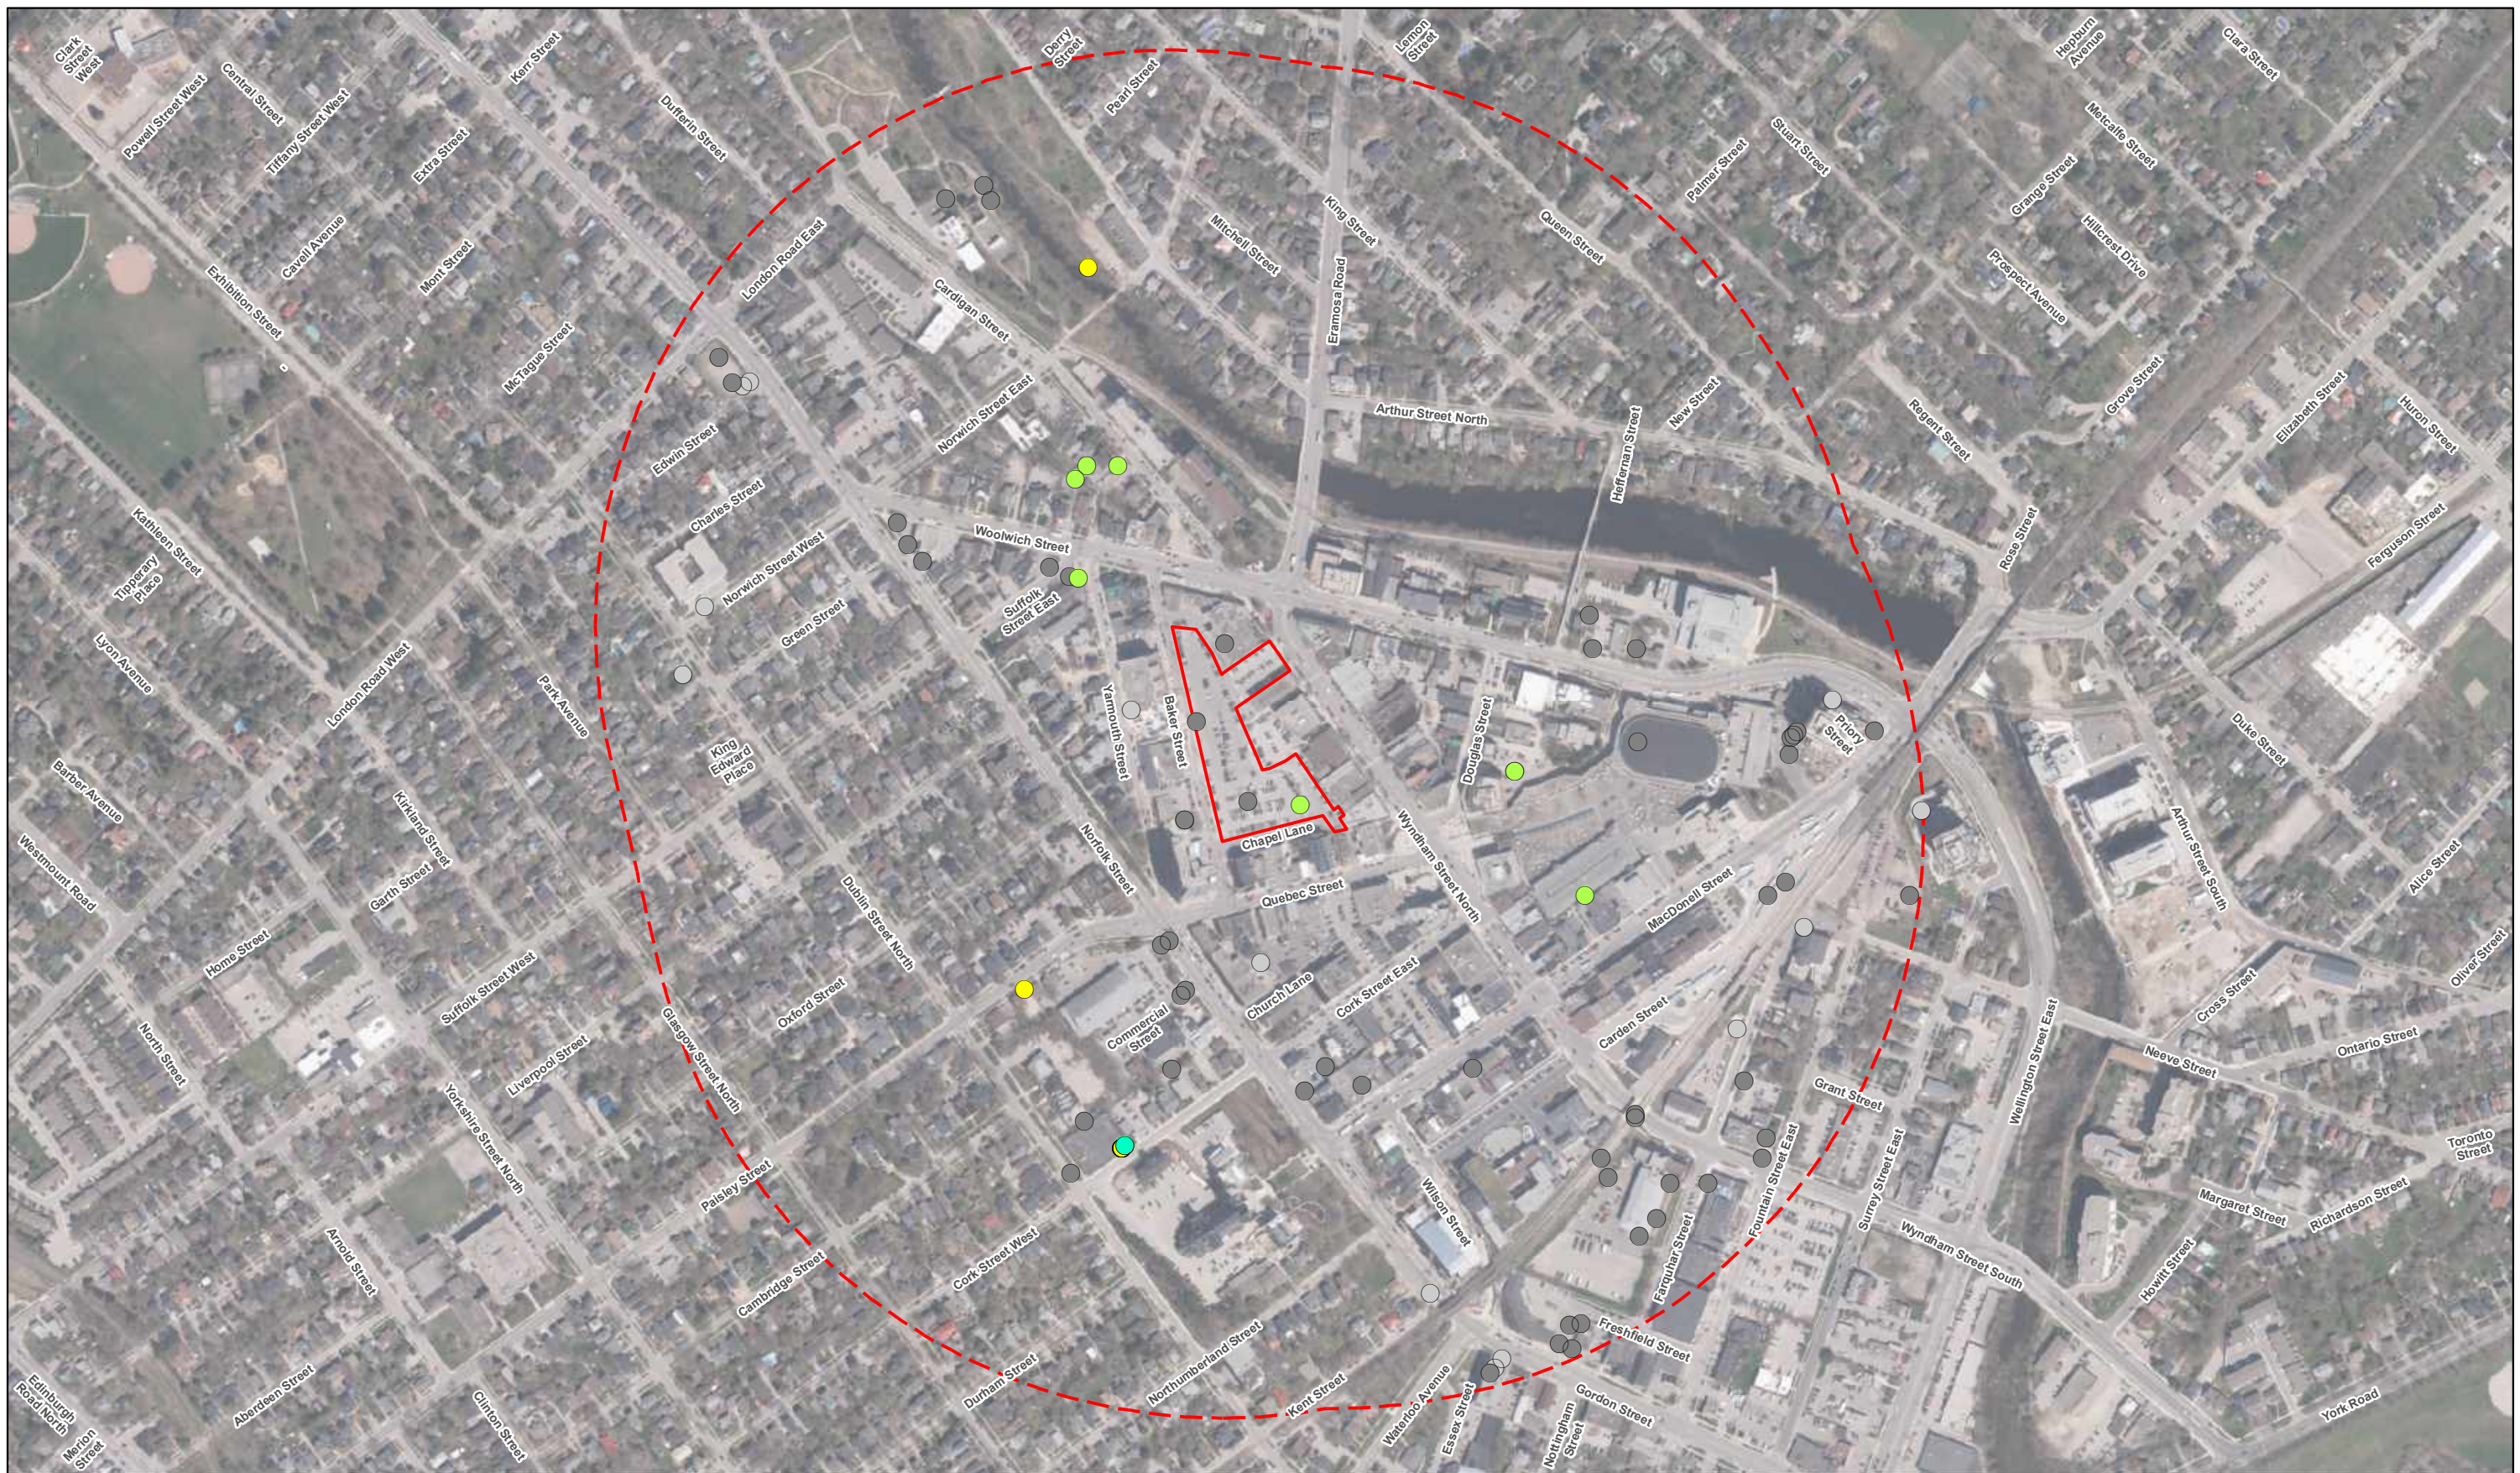
**Figure D1-1**  
 Ontario Water Well Records Near Project Site  
 Phase One Environmental Site Assessment Summary  
 55 Baker Street, 152 and 160 Wyndham Street  
 North and Park Lane, Guelph, Ontario  
 Date Exported: 11/25/2020

- Site Boundary
- Site Boundary - 500m Buffer
- Water Supply Well
- Recharge Well
- Dewatering Well, Not Used
- Purpose not available
- Monitoring Well or Test Hole

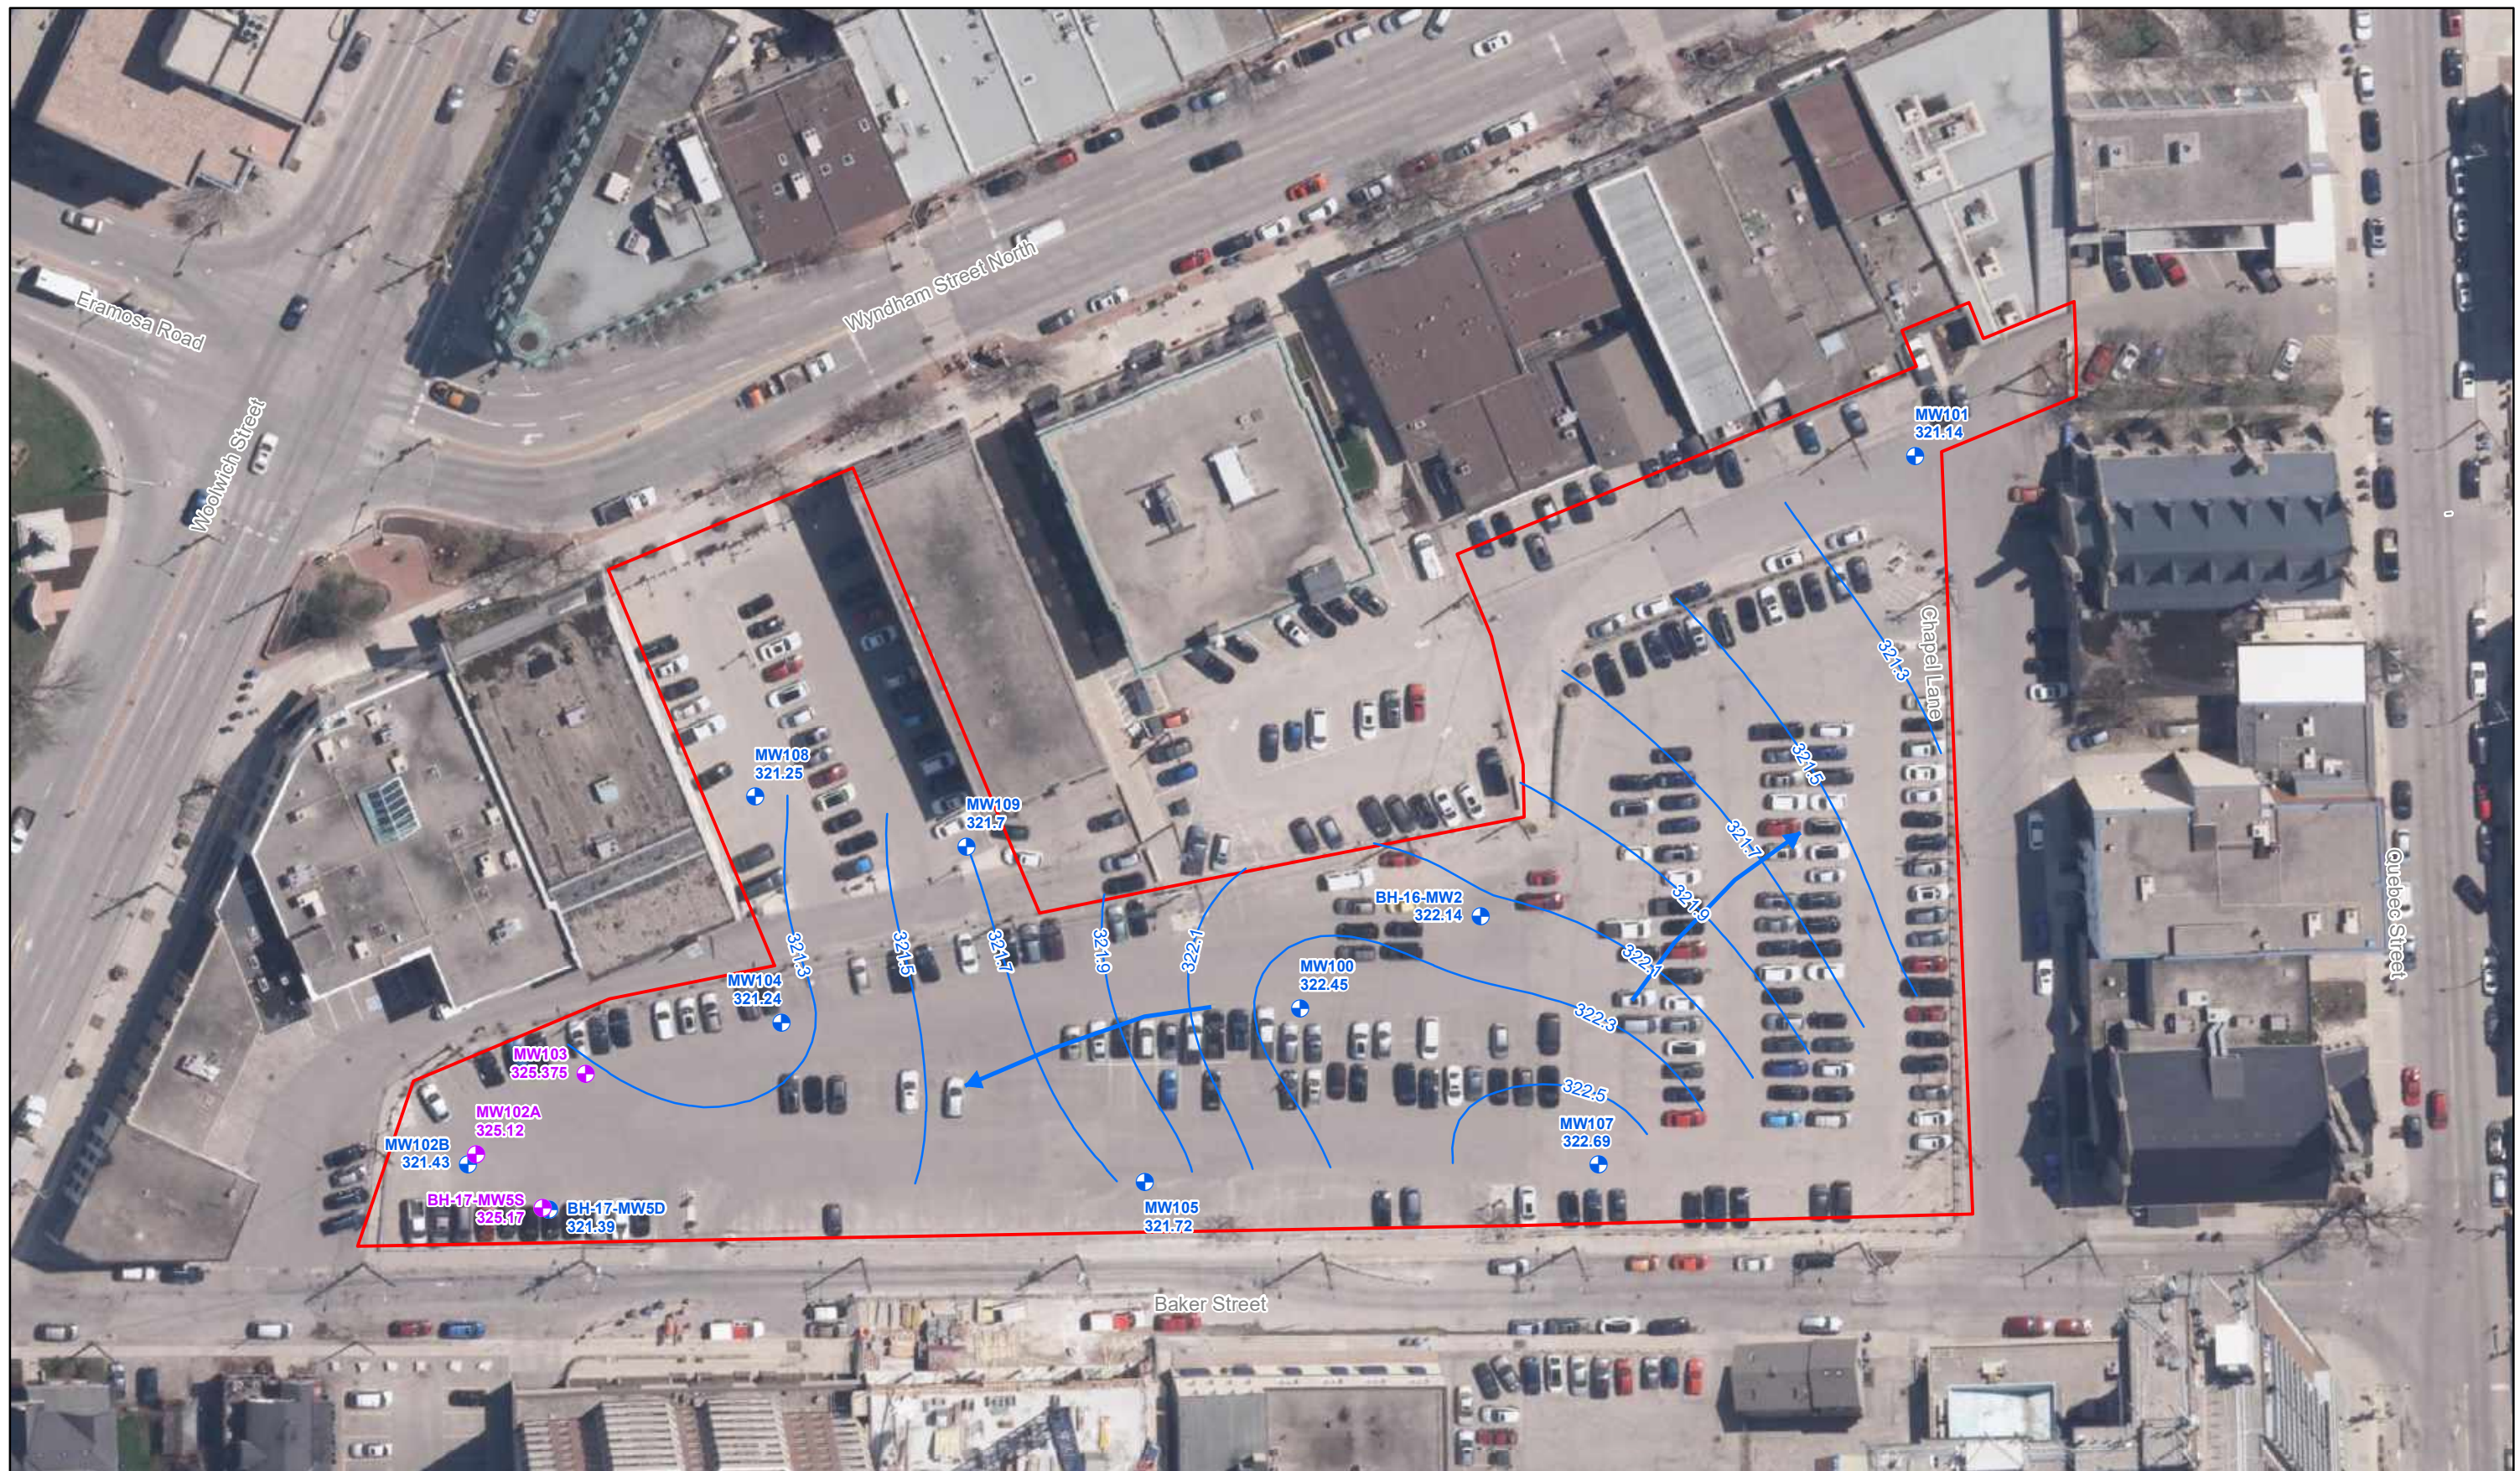
**Figure 6-2a**  
 Groundwater Contours - September 2019  
 Phase Two Environmental Site Assessment  
 55 Baker Street, 152 and 160 Wyndham Street  
 North and Park Lane, Guelph, Ontario  
 Date Exported: 6/9/2020

September 18, 2019 Groundwater Elevations (mASL)

<sup>4</sup> Regional groundwater flow was inferred to be towards Speed River (north to north-east); site-specific groundwater flow was shown to be towards the north on the north portion of the Site, and to the east on the southern portion of the Site (see Figures 6-2a to 6-2c). Some of the upgradient/downgradient terminology may have changed from the Pinchin (2018) report based on this updated interpretation.

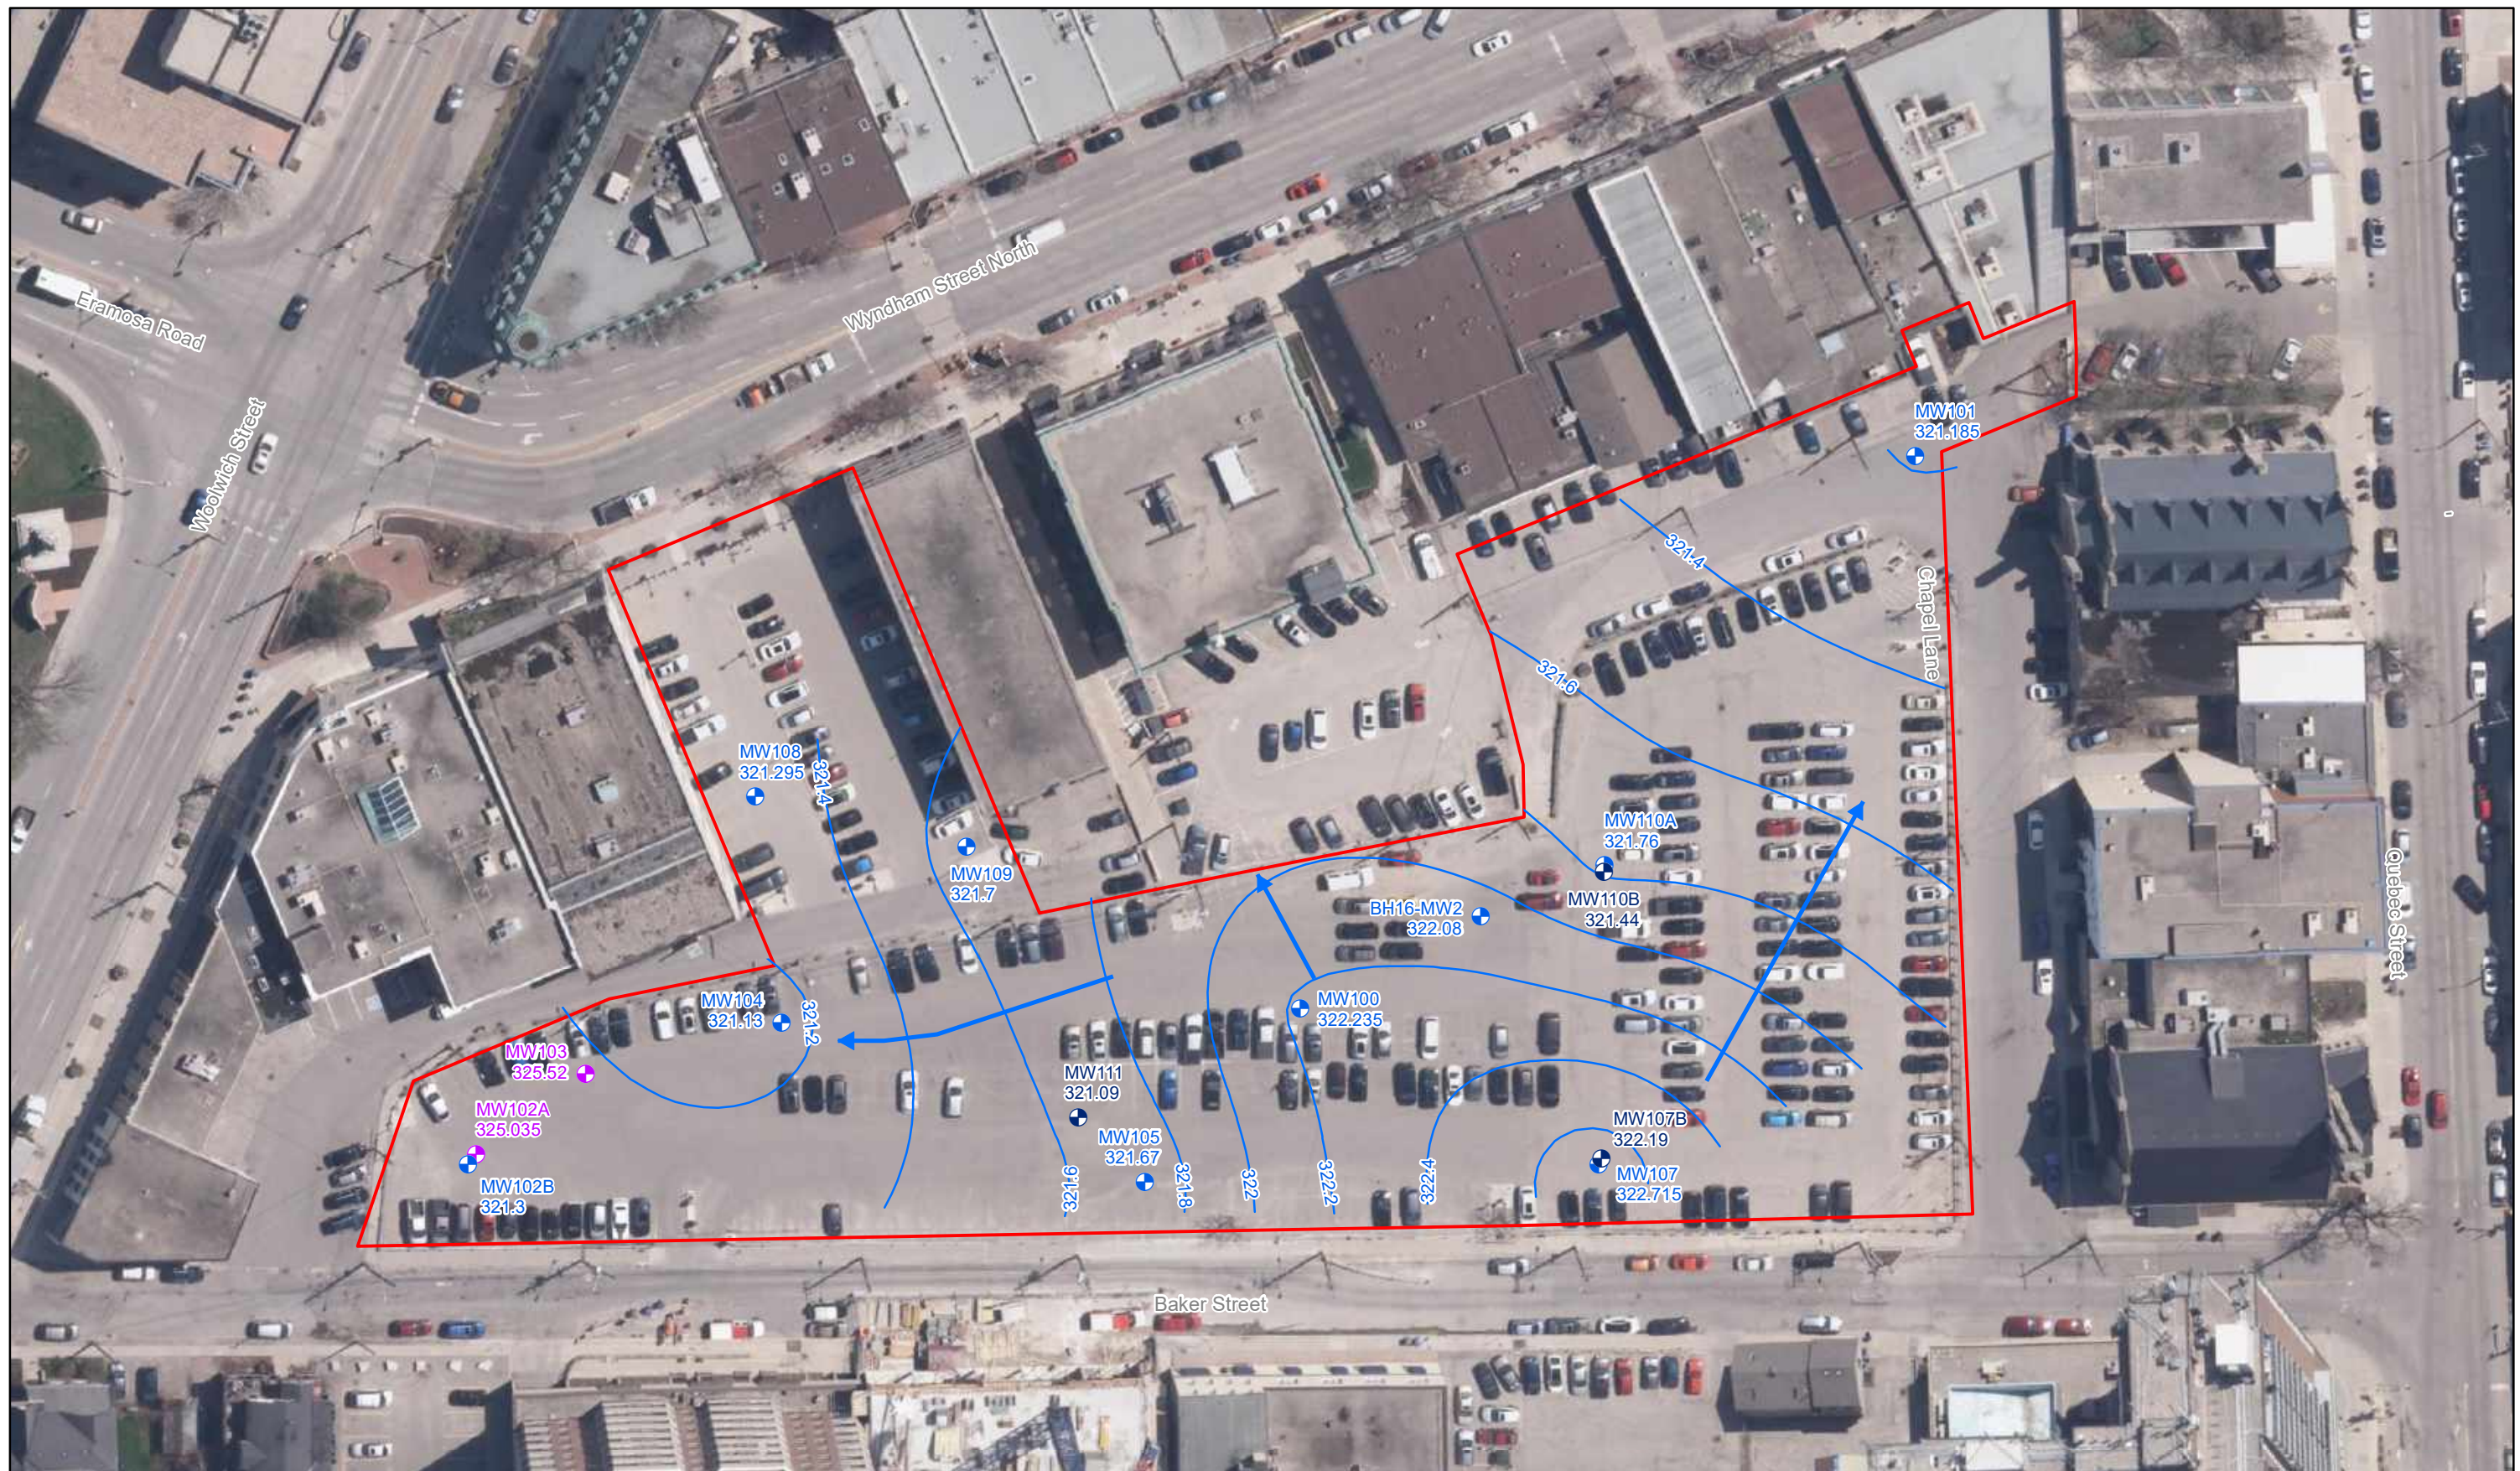
**Figure H-3a**  
 Groundwater Contours - September 2019  
 MGRA Supporting Information  
 55 Baker Street, 152 and 160 Wyndham Street  
 North and Park Lane, Guelph, Ontario  
 Date Exported: 6/9/2020

December 18, 2019 Groundwater Elevations (mASL)

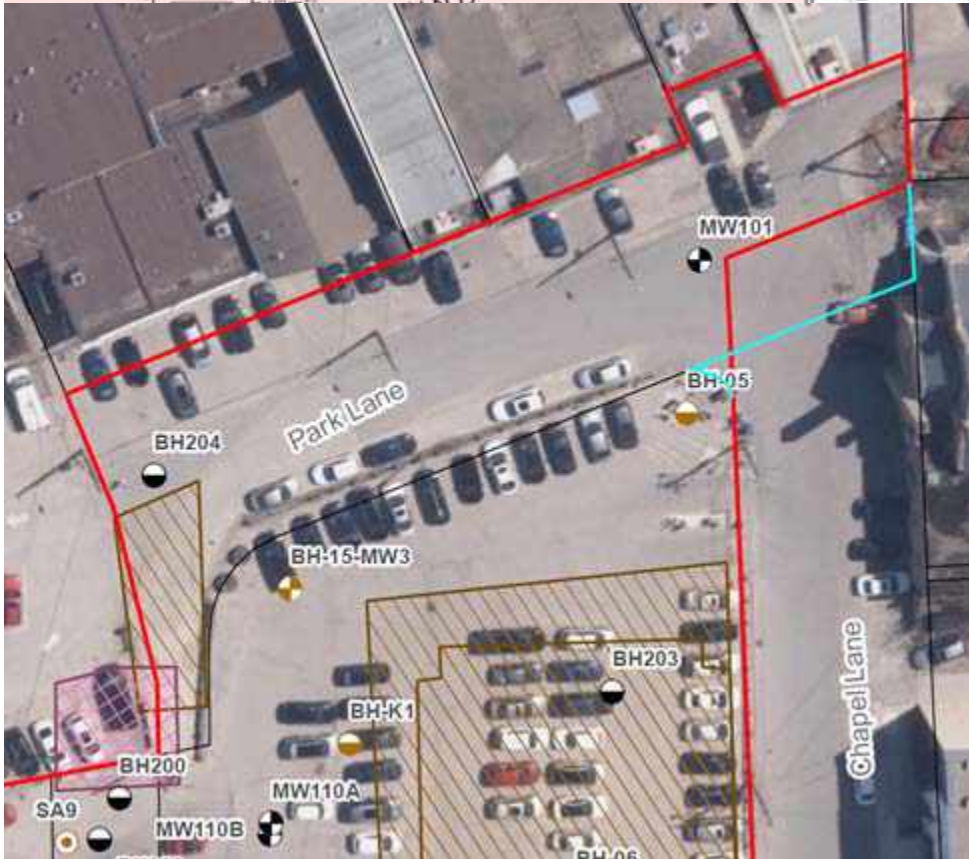
Specifically, the change reduces the footprint of Park Lane as well as adds a small area (small curve) at what used to be a corner abutting Chapel Lane, which are shown and described below:

- Screen capture of the Legal Survey and the RA Property identified in Attachment A of the PSF/MGRA; this represents the correct legal Site/RA Property Boundary (light red shading).
- Screen capture of a Phase Two ESA CSM plan-view figure. The "incorrect" boundary (provided with the October 21 PSF/MGRA submission) is provided in light blue; the corrected Property boundary is shown in red (which aligns with the Legal Survey).
